# **Index Plungers** • simple finish

22120.0748

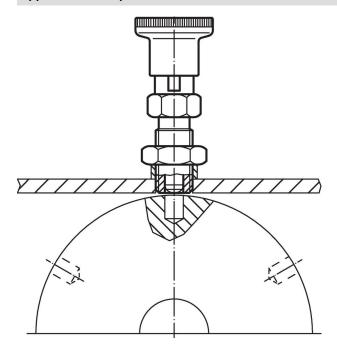
## **Application example**

When using locking index plungers, the knob is pulled-out, turned 90° and secured by a notched catch (when locking pin should not overhang).
