# **Index Plungers** • simple finish

22120.0766

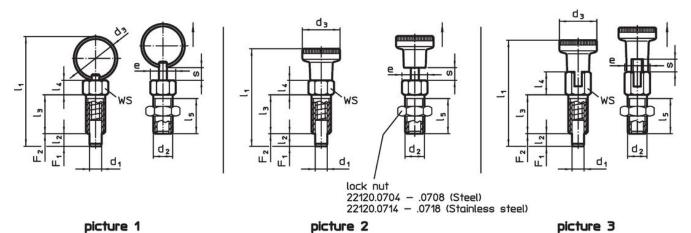
# **Drawing**

Dimensions									ws	Tightening Spring load <sup>1)</sup>					I	Art. No.	
<b>d</b> <sub>1</sub>	d <sub>2</sub>	d <sub>3</sub>	e	I <sub>1</sub>	l₂ min.	l <sub>3</sub>	I <sub>4</sub>	l <sub>5</sub>	s min.		max.	F <sub>1</sub> ~	F <sub>2</sub> ~	min.	max.		
[mm]								[mm]	[Nm]		[N]	[°C	]	[g]			
with knob and locking – picture 3, Steel																	
6	M10	18	11.5	52	6	20	10.5	17	6	10	15	5	21	-30	80	18	22120.0766
