## Lateral Plungers • with thread, without seal, with female thread

22150.1340

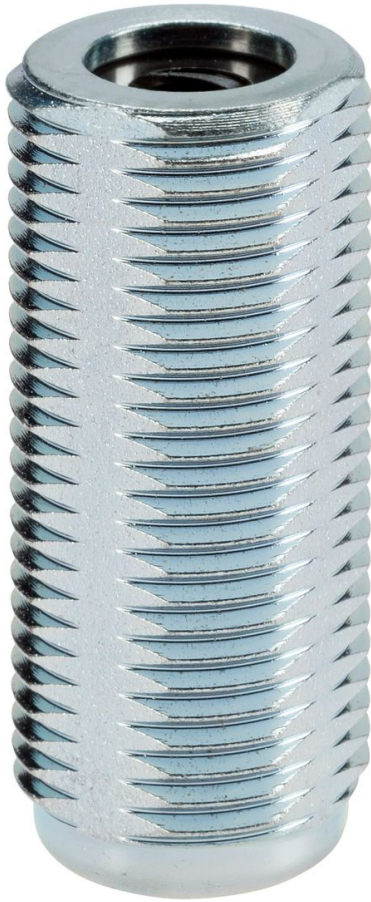
### Product Description

To be used for positioning and applying pressure, e.g. during painting and sandblasting.

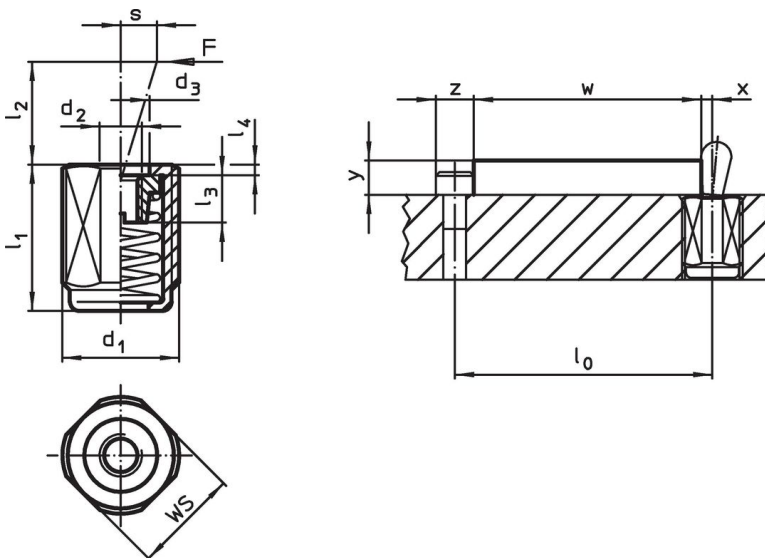
### Drawing

Formula for calculating the center distance for the mounting hole:

$$l_0 = z/2 + w + x,$$

$l_0$  = center distance,

$y$  = workpiece height,

$w$  = workpiece length,

$x$  = stroke,

$z$  = stop diameter

Calculation dimension  $x$  for workpieces:

$$x = d_2/2 - s$$

[g]	Art. No.
d <sub>1</sub>	l <sub>1</sub> -2				l <sub>2</sub>	l <sub>3</sub>	l <sub>4</sub>					
[mm]					[mm]							
Heavy spring load												
M12	26.5	100	M4	6.1	7.5	4.5	1.5	2	10	250	8.6	22150.1340

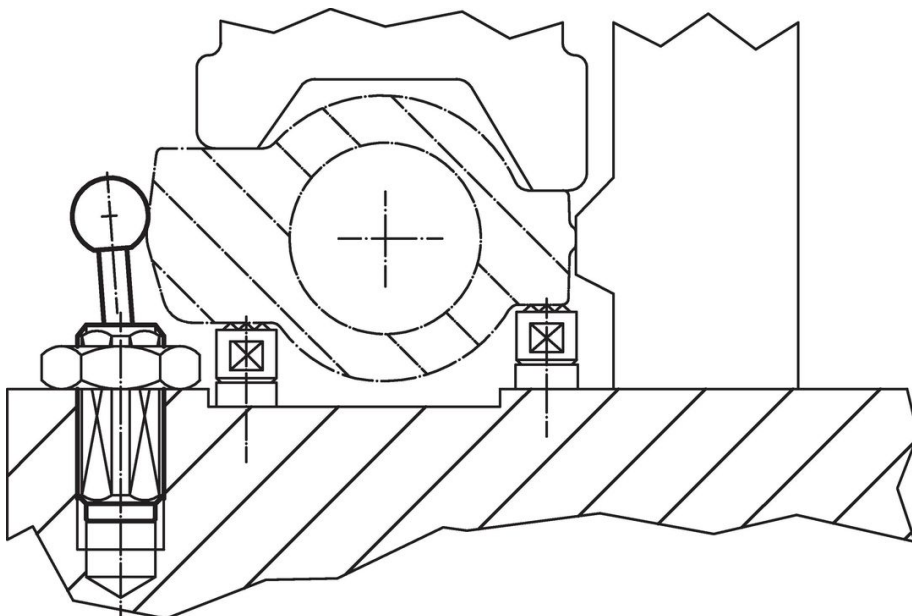
## Application example

Lateral plungers are installed by screwing in by means of a mounting tool.
